## **MARINE SURVEY REPORT**

**“M/S POLARWIND“**

**CONDITION SURVEY**

Type : Motor Sailing Yacht  
Location : Finike Marina / Antalya/TURKEY  
Date : 07.09.2020

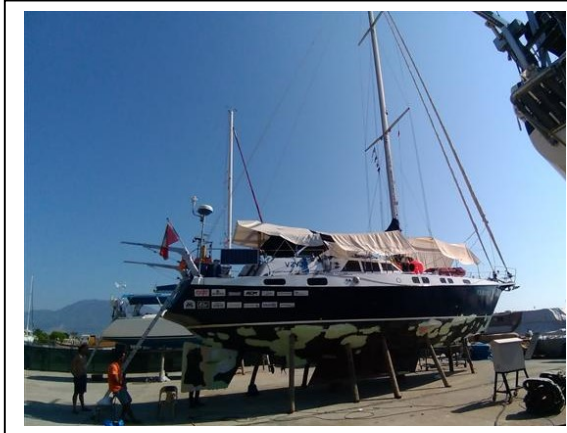
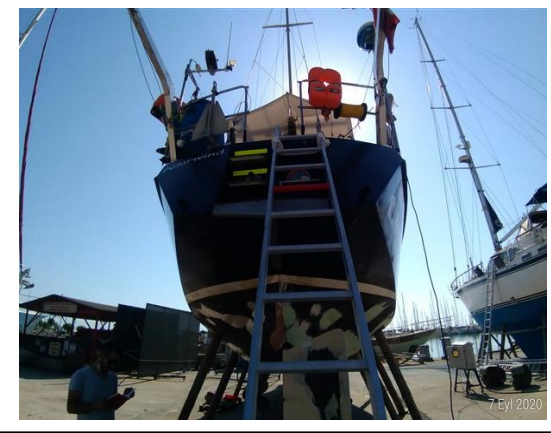
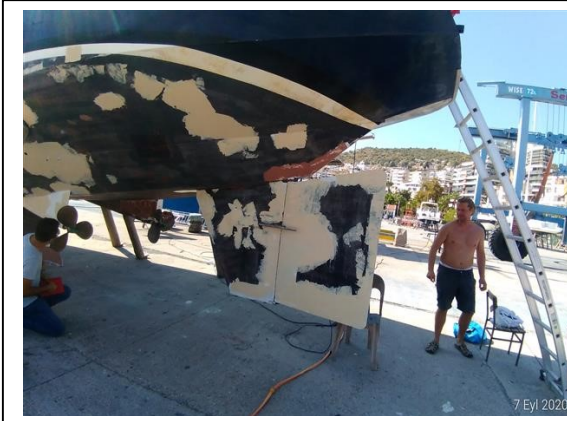
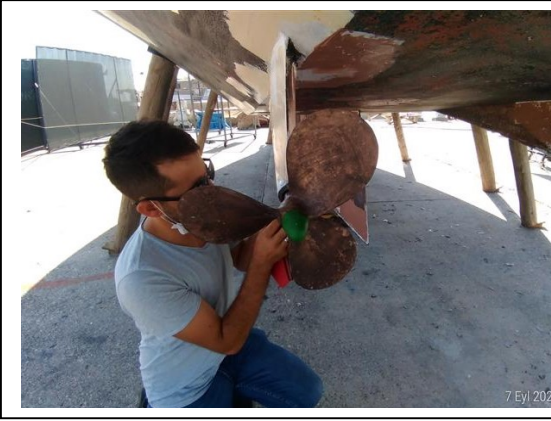
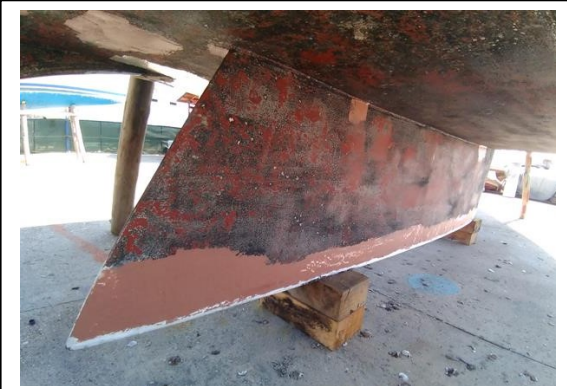
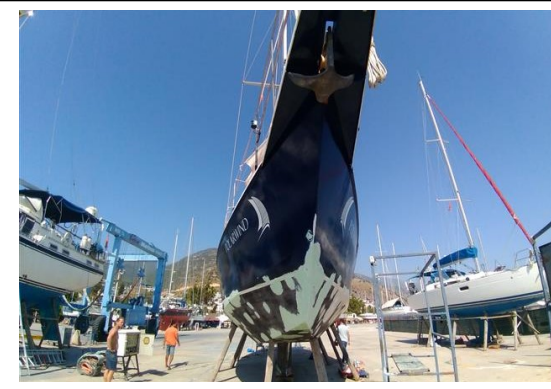
## V. HULL BELOW THE WATERLINE

The yacht was on land so the hull below the waterline had been examined. The underwater area, the freeboard area (above the waterline) is free of any damage and visually in “ACCEPTABLE CONDITION”. The discharge of waters and the clearances of the propeller shafts and boss had been examined and found in tolerable condition. The shell plating had been partially painted and covered with paste already so had to be examined by visually. The last steel thickness measurements report are required but the owner could not verify the report. The shell thickness has to be verified by NDT methods for the next docking.

1. The steel hull shell plating and main structure has to be NDT tested for the thickness and reported by a verified company.
2. All the fire extinguishers -To be serviced & certificated
3. Advisory-Installation of an automatic extinguisher in the engine room.
4. Installation of a smoke alarm in the engine room.
5. The Liferaft has to be Serviced or renewed.
6. The register has to be renewed for the new engines.

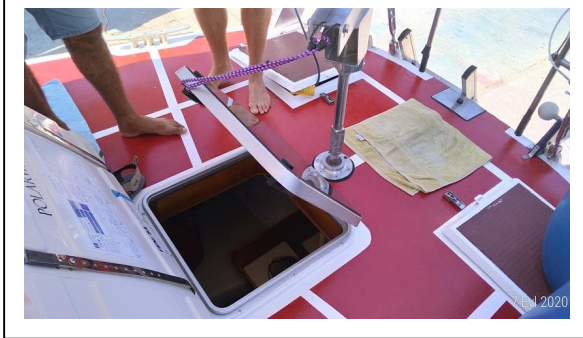
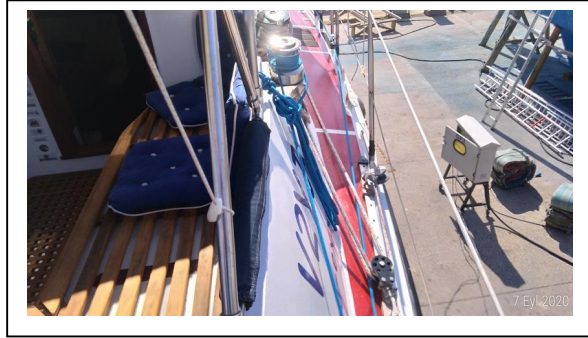
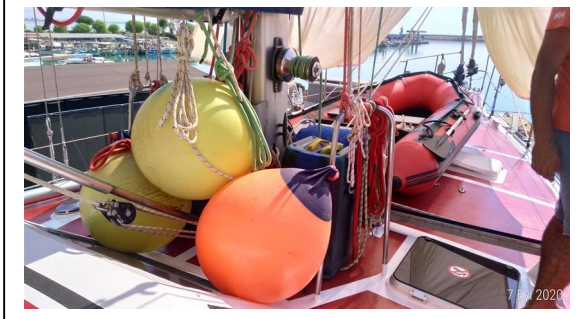
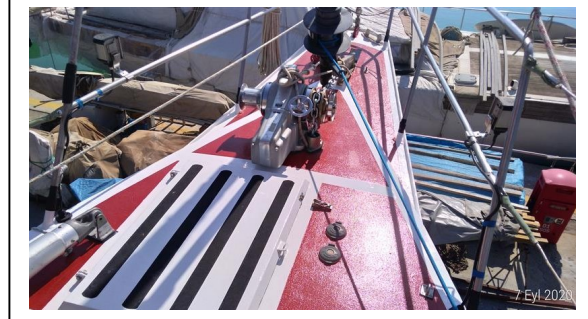
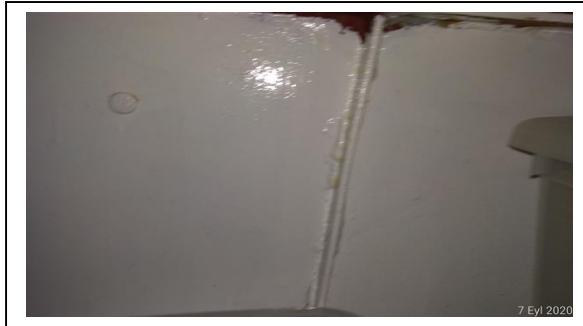
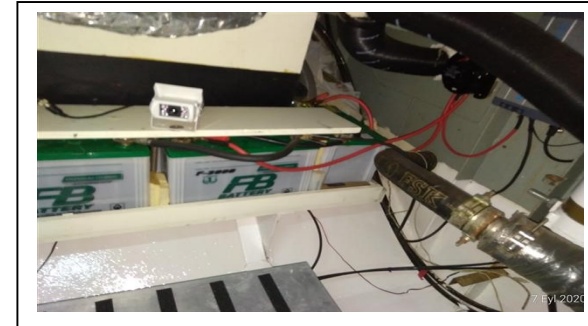
## **VI. HULL DECK AND SUPERSTRUCTURE**

The hull and the deck made from steel. The deck painted with anti-skid paint and found in ACCAPTABLE CONDITION. The hull is provided with satisfactory structural elements/reinforcements. Due to fixed interiors and lining, access to the structure was very limited.

The parts of deck-hull joints, bulkhead-deck joints, frames, floors, longitudinal stiffeners, reinforcements, mast step, as far as seen at visual inspection were found in "ACCAPTABLE CONDITION". The structural integrity of the hull, as far as seen, was found to be good.

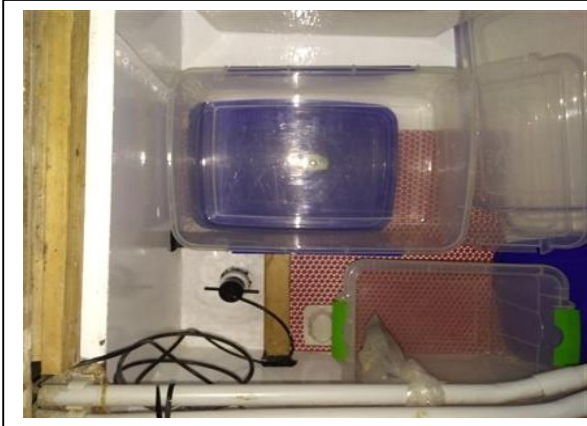
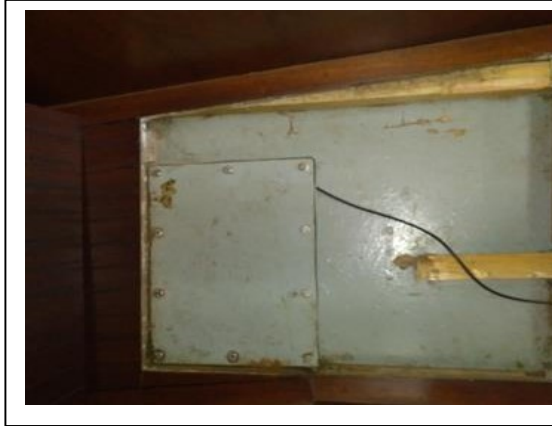
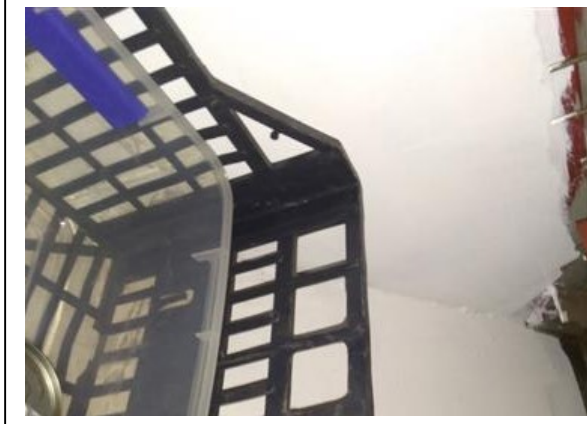
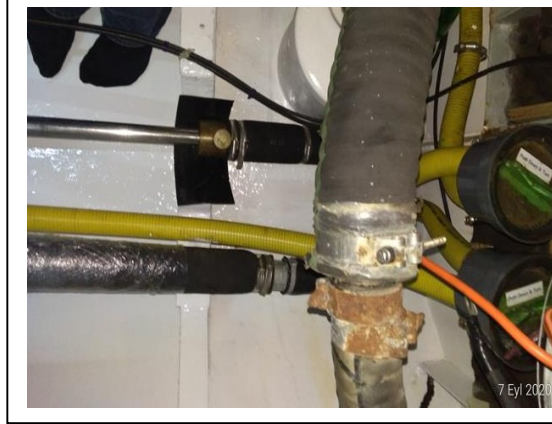
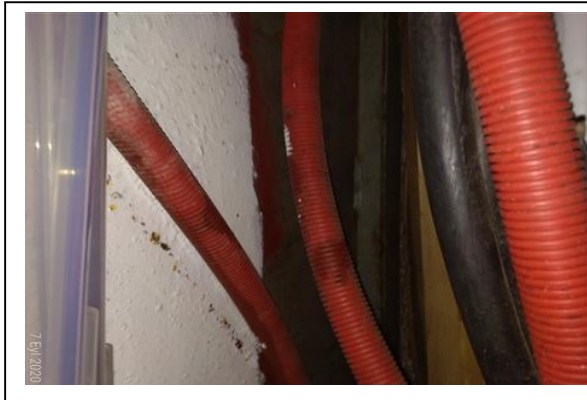
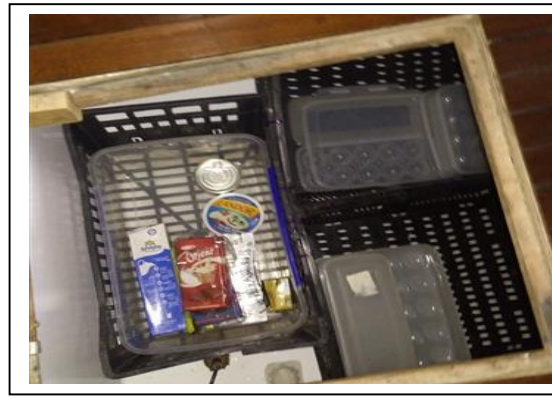
## **VII.INSIDES AND BILGES**

The bilges were found dry and and satisfactory, the equipments are assambled and found in “ACCAPTABLE” condition. Also the pipelines, valves, electrical cables, connections with the equipments are seemed to be in order, There were some metallic corrosions found on the exhaust flexible pipes connections and asked to be renewed. The bilge pumps, other pumps and the pipe connections are found satisfactory.The tanks had no leakage and had been found in “ACCAPTABLE” condition.

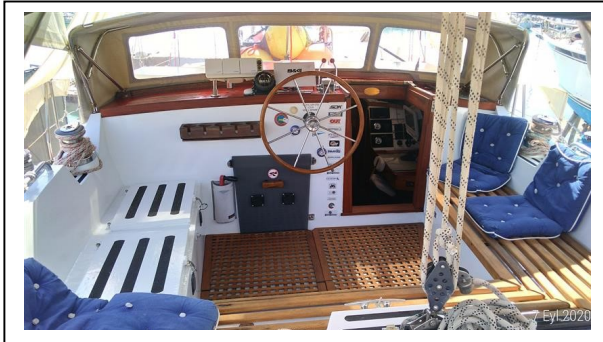
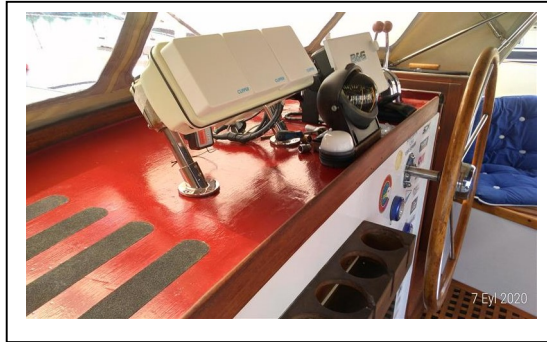
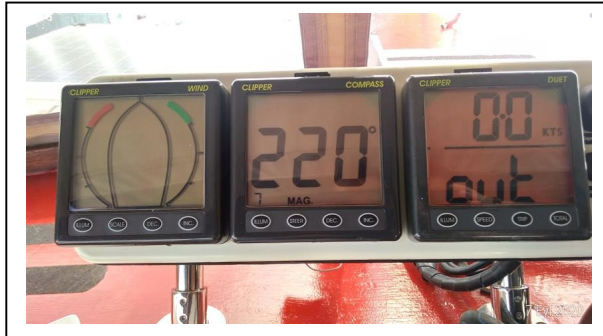
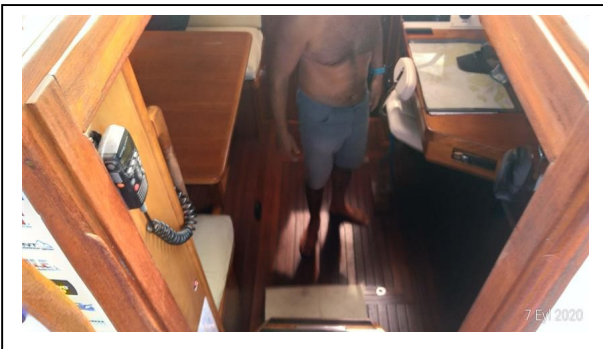
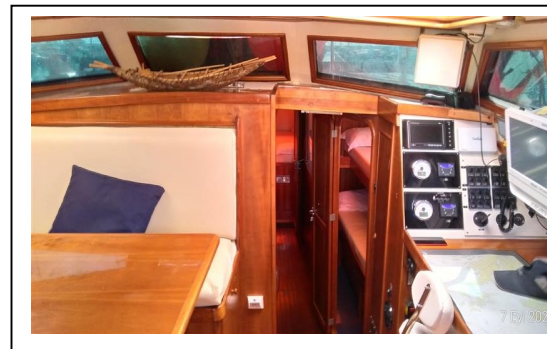
## **VIII. AFT DECK POOL & INTERIORS**

The aft pool started with a center console than seats on the both sides and a passage to the saloon. The saloon area is at the mast area and the L-type seat are located on the portside to the back side, also there is a chart table on the starboard side. The front of the saloon is arranged for the kitchen.

The navigation table, navigation equipment and DC/AC panels are placed on the console and starboard side of the entrance salon. The equipments had been tested with on/off positions.

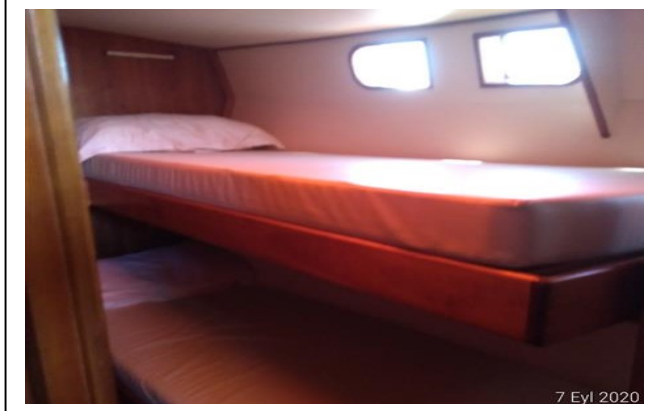
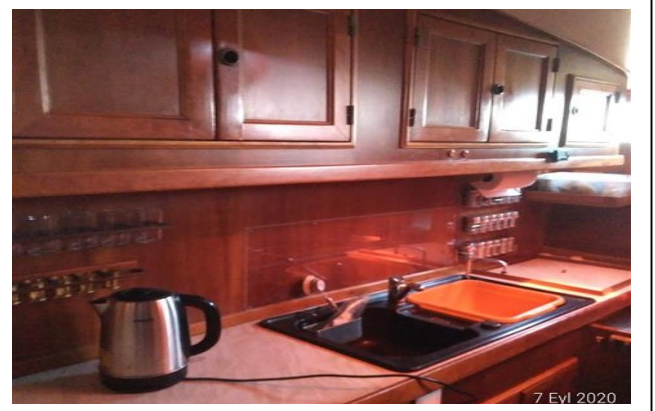
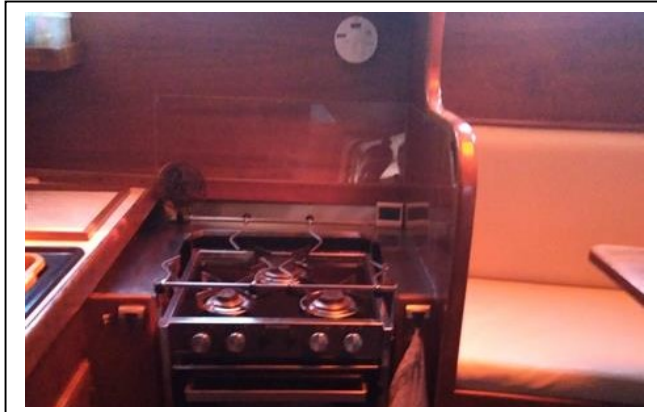
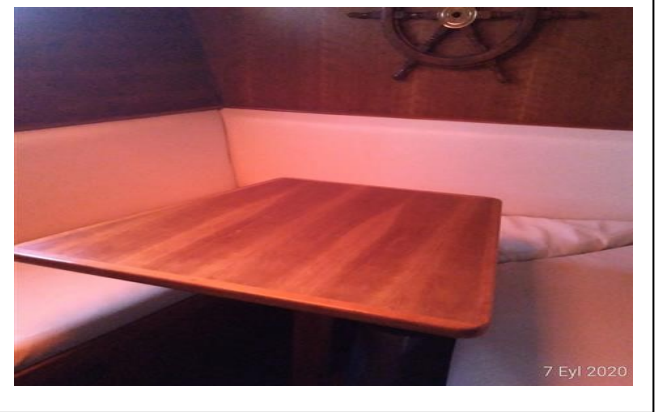
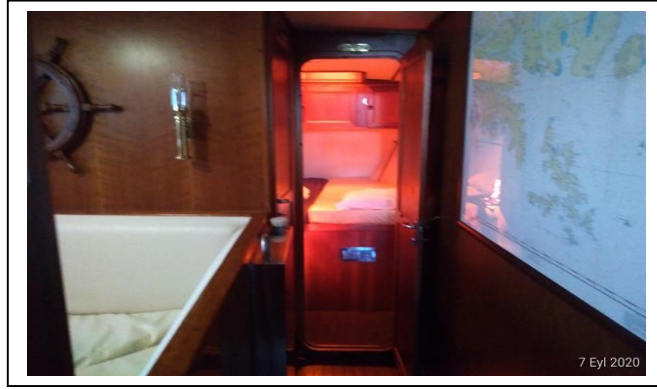
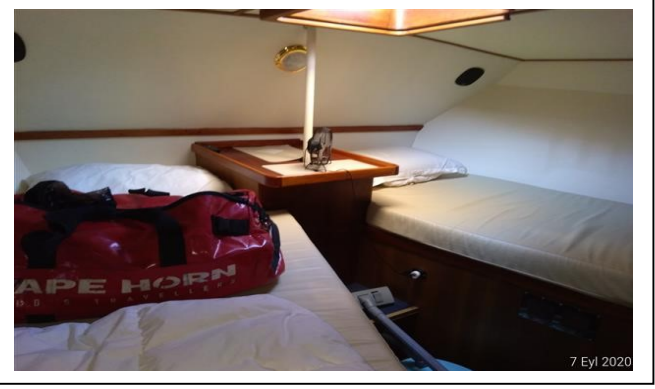
The console on the deck equipped with digital navigation devices with engine watches. The VHF has been tested and found working in good condition.

The interior of the yacht, saloon and the cabins are furnished and seems to be in "ACCAPTABLE CONDITION" .

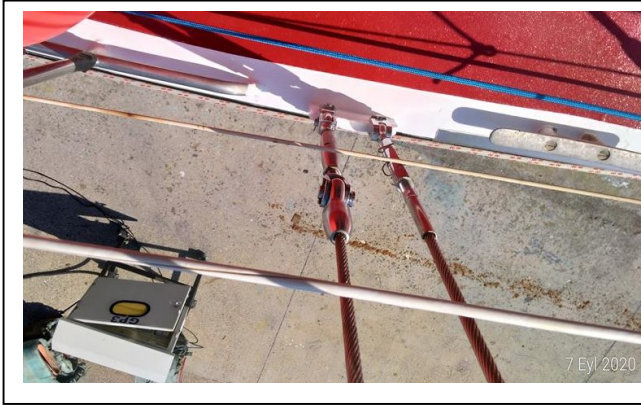
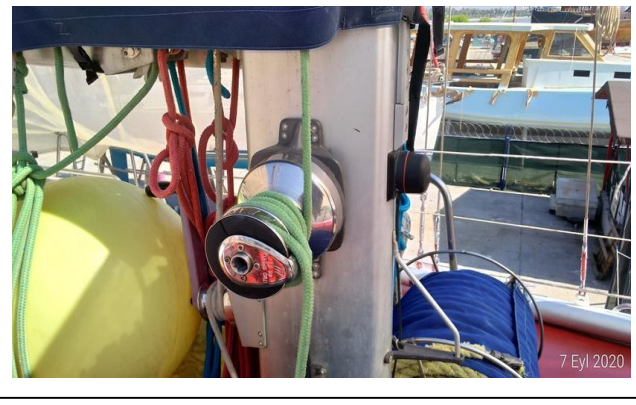
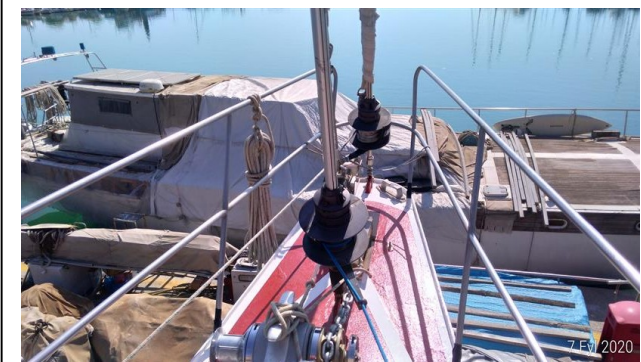
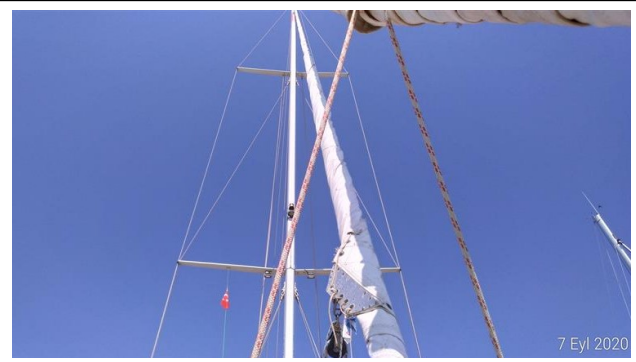
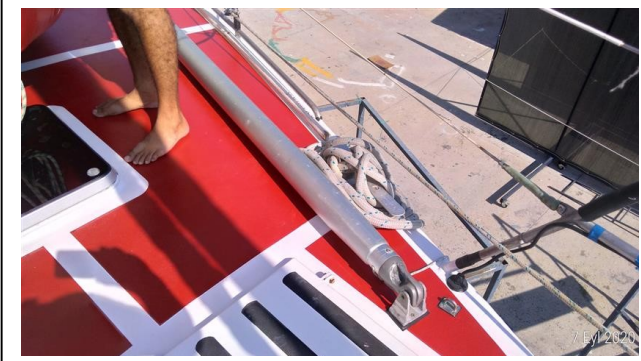
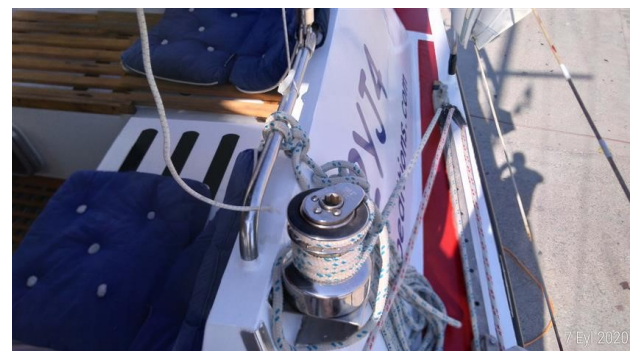
## **IX. RIGGING & SAILS**

Main mast stepped on deck and supported via stainless steel ropes which is mounted on the deck. The mast, furling, railings and base are in good condition. Mast and spar is free of any visible damage and it's joints to boom and mast are in good condition. The sails, winches, peripherals are in "ACCAPTABLE CONDITION".

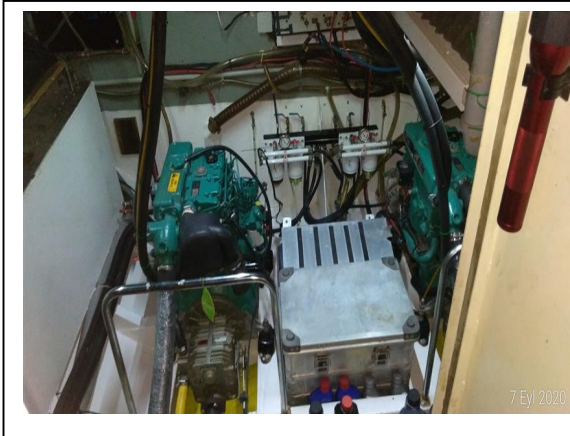
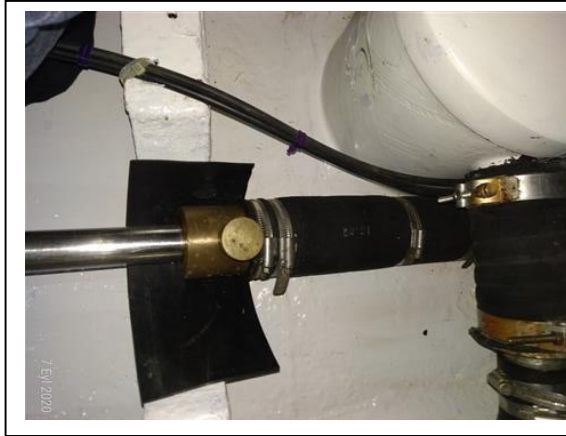
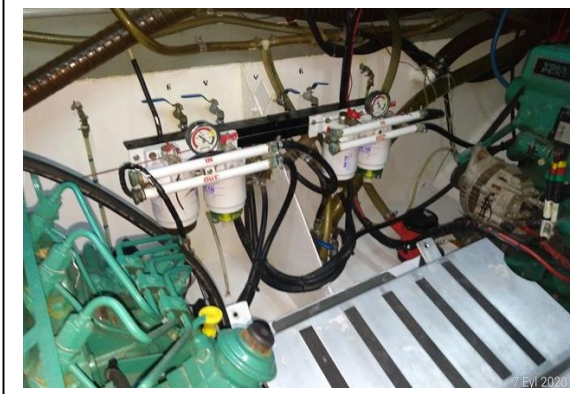
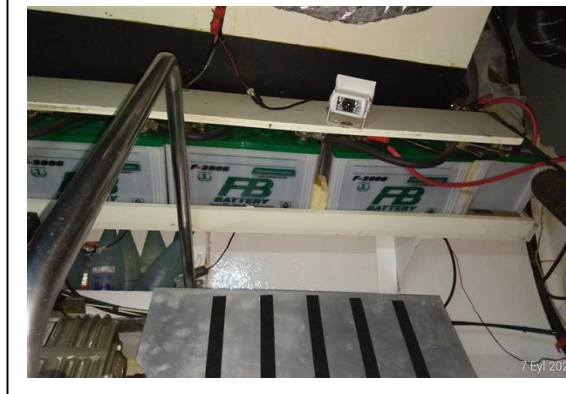
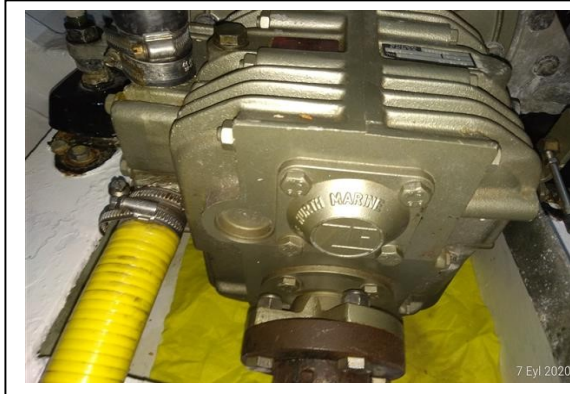
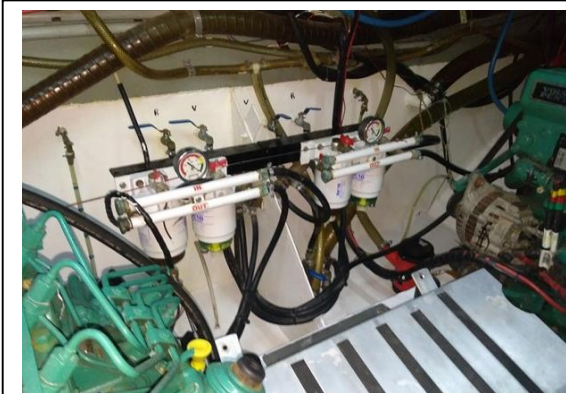
## **X. MACHINERY & PROPULSION**

The yacht engine room is located under the main deck where the entrance can be done from the back cabin. There were two main engines are located in the engine room and emergency generator on deck. The engines are Volvo Penta D2- 55F (55 HP) connected to the conventional shaft system. The engines can be controlled on the main center console . The coupling on the gearbox and the shafts were found in good condition. The general condition of engines, mountings, gearbox, shaft connections are in "GOOD CONDITION". The steering is on the main deck console which is located on the center. The rudder has been tested and can rotate with a hand force. The batteries are located on the starboard side in the engine room.

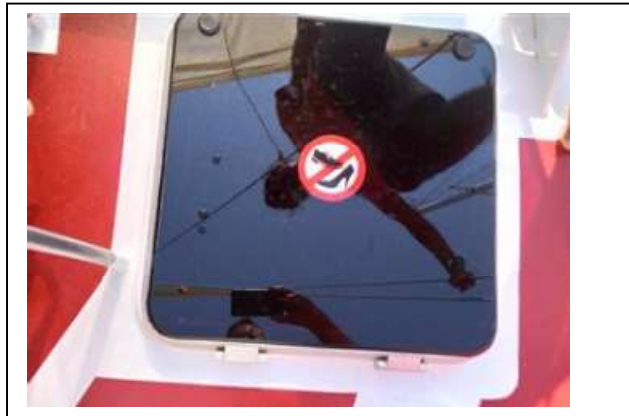
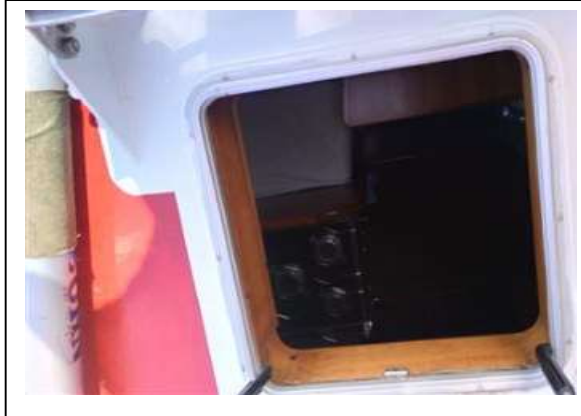
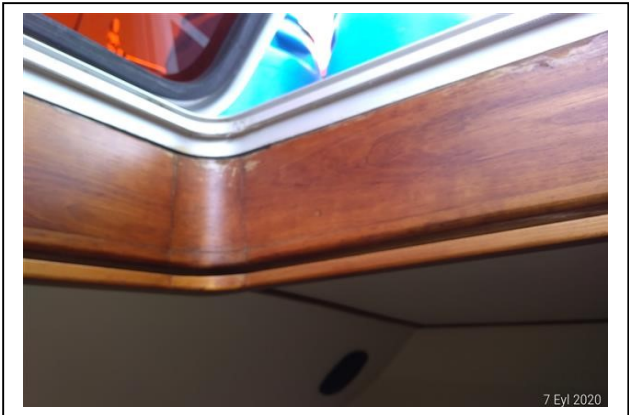
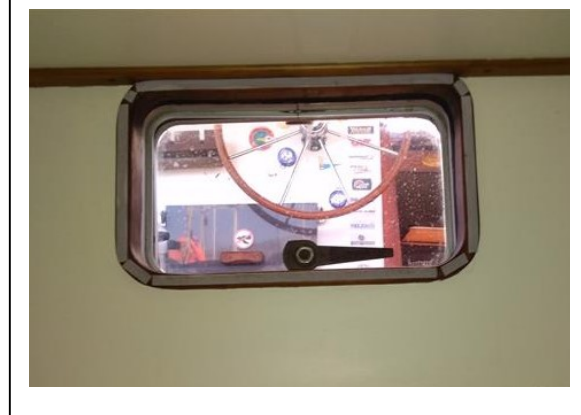
### **XI- OPENNINGS & HATCHES**

All the openings has been checked for tightness. The main salon entrance door, deck hatches, portholes found to be in "ACCAPTABLE CONDITION, there was no leakage founded .

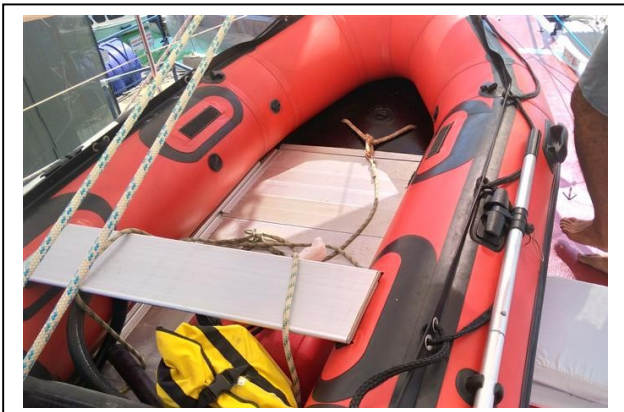
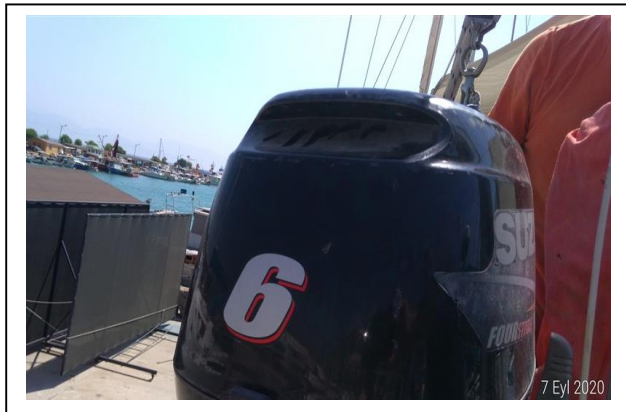
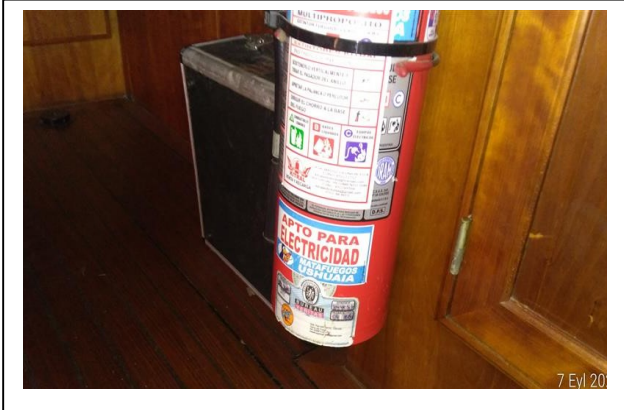
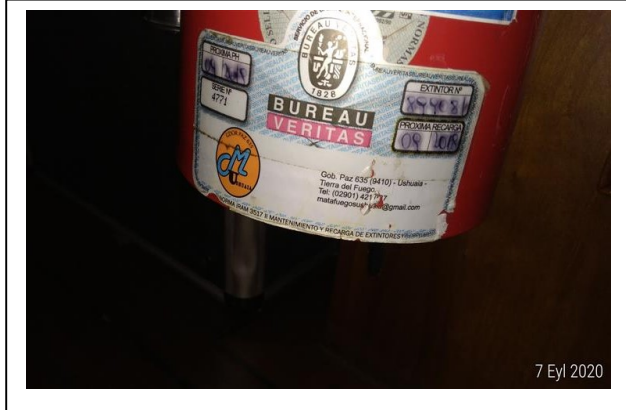
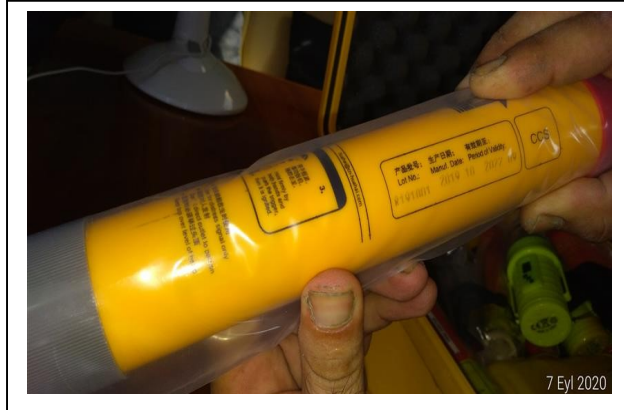
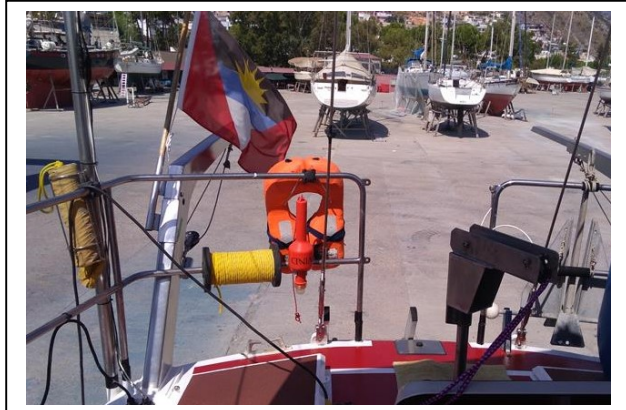
## XII. FIRE & SAFETY EQUIPMENTS

The portable fire extinguishers are found on board ,The portable extinguishers has to be serviced and cetrificated. The validity has been finished on 2018 . It is recommended to install automatic fire extinguishers in the engine room and smoke alarm . The yacht has a life raft but it is not serviced. The owner will service or will buy a new one. The RIB tender boat was on the deck with a 6 HP Suzuki – outboard engine. There were signal flags, pyrotechnics and life jackets on board. There are smoke alarms in the cabin areas, and recommended to install one in the engine room. There were also cameras in the engine room.

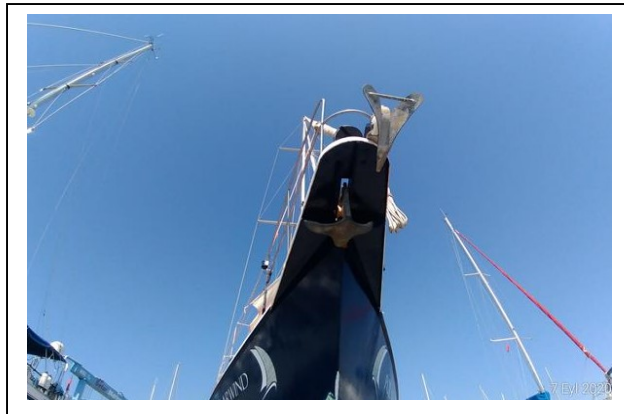
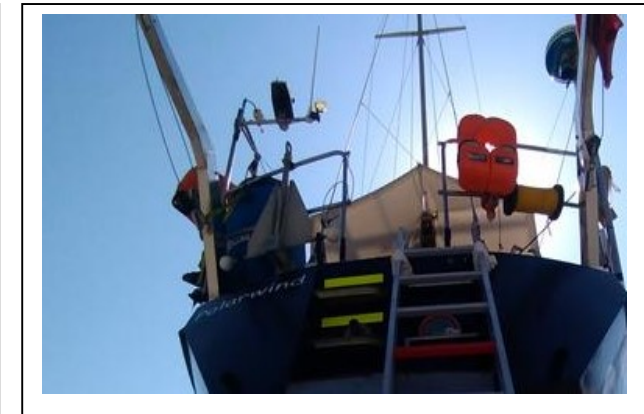
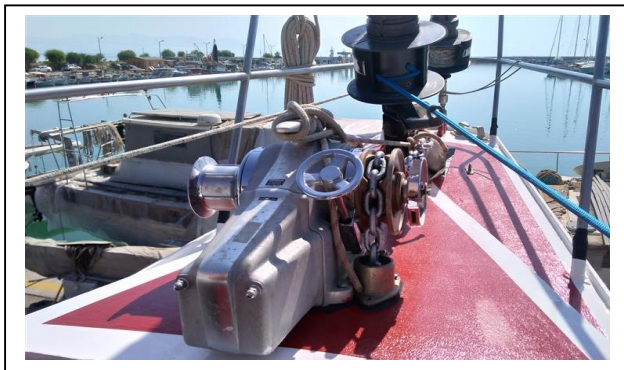
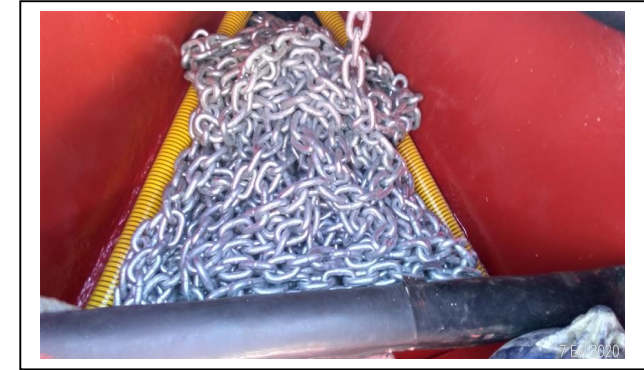
### **XIII. ANCHOR WINCH AND CHAIN**

The anchor winch, anchors, the ropes and the chain, has been examined and found in ACCEPTABLE CONDITION.
