## **MARINE SURVEY REPORT**

**“M/S POLARWIND“**

**CONDITION SURVEY**

Type : Motor Sailing Yacht  
Location : Finike Marina / Antalya/TURKEY  
Date : 07.09.2020

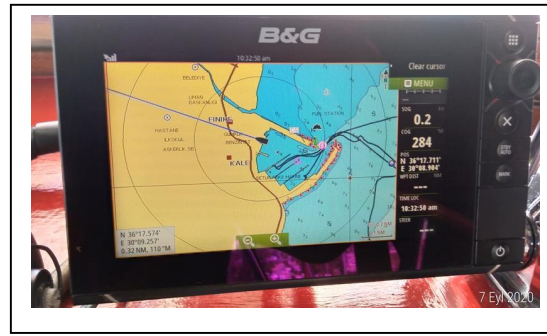
The console on the deck equipped with digital navigation devices with engine watches. The VHF has been tested and found working in good condition.

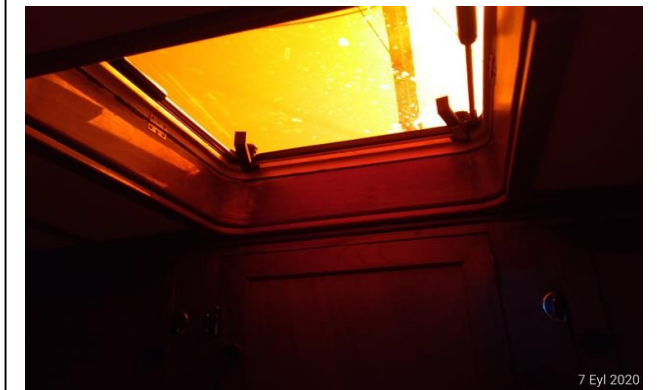
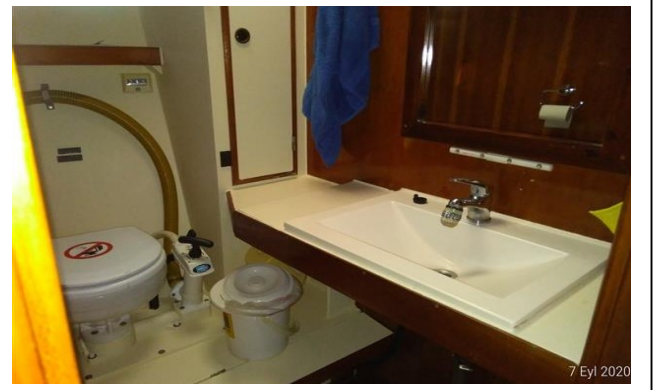
The interior of the yacht, saloon and the cabins are furnished and seems to be in "ACCAPTABLE CONDITION" .

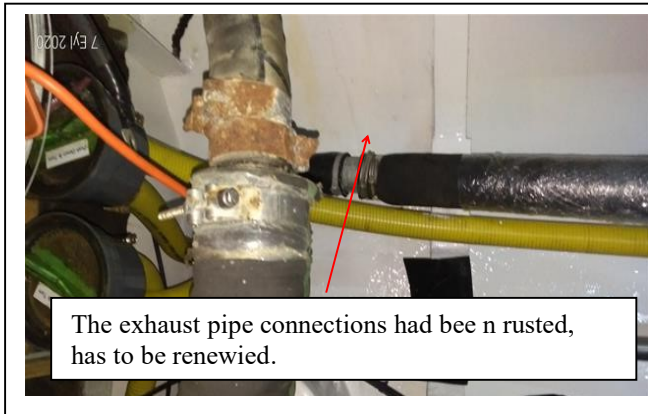
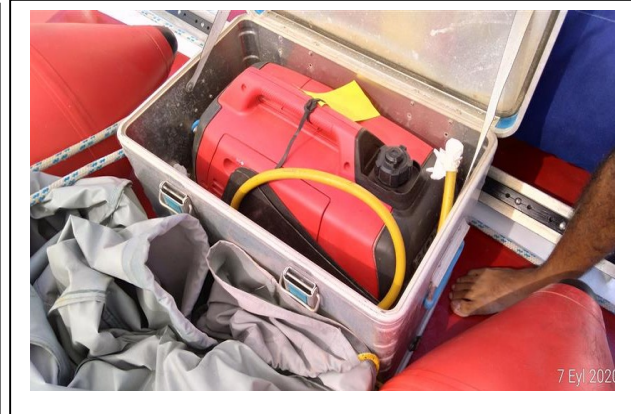
The yacht engine room is located under the main deck where the entrance can be done from the back cabin. There were two main engines are located in the engine room and emergency generator on deck. The engines are Volvo Penta D2- 55F (55 HP) connected to the conventional shaft system. The engines can be controlled on the main center console . The coupling on the gearbox and the shafts were found in good condition. The general condition of engines, mountings, gearbox, shaft connections are in "GOOD CONDITION". The steering is on the main deck console which is located on the center. The rudder has been tested and can rotate with a hand force. The batteries are located on the starboard side in the engine room.

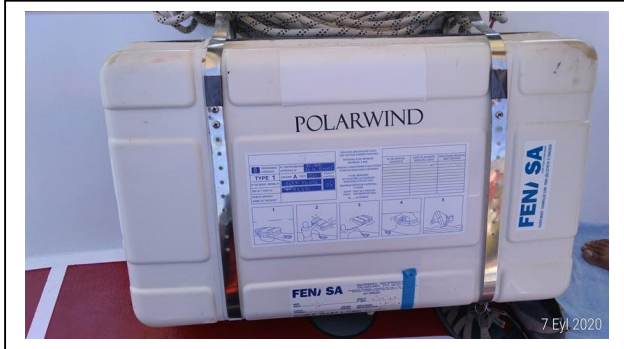
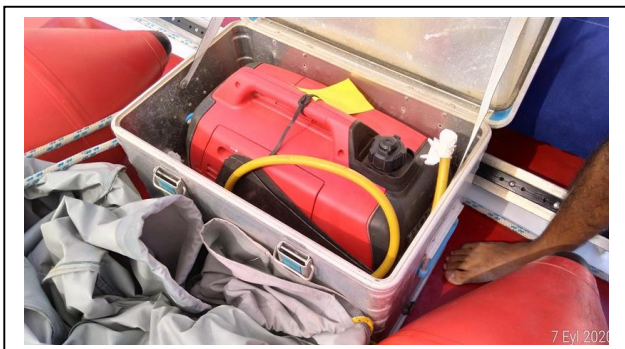
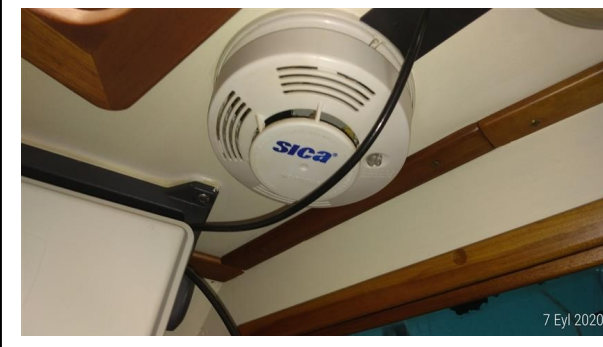
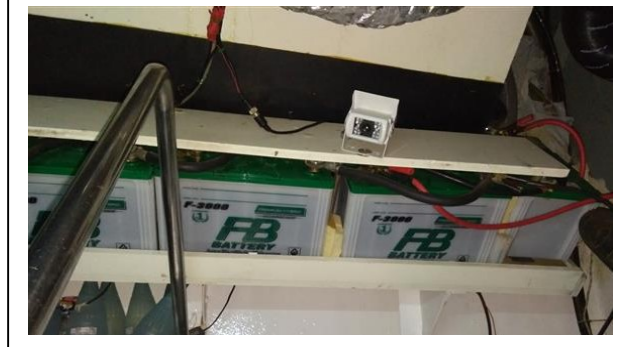
The portable fire extinguishers are found on board ,The portable extinguishers has to be serviced and cetrificated. The validity has been finished on 2018 . It is recommended to install automatic fire extinguishers in the engine room and smoke alarm . The yacht has a life raft but it is not serviced. The owner will service or will buy a new one. The RIB tender boat was on the deck with a 6 HP Suzuki – outboard engine. There were signal flags, pyrotechnics and life jackets on board. There are smoke alarms in the cabin areas, and recommended to install one in the engine room. There were also cameras in the engine room.

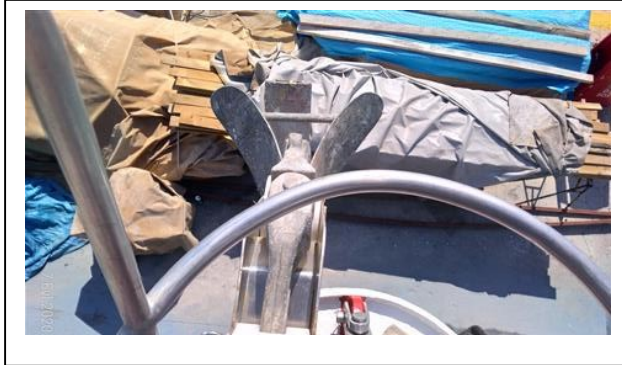
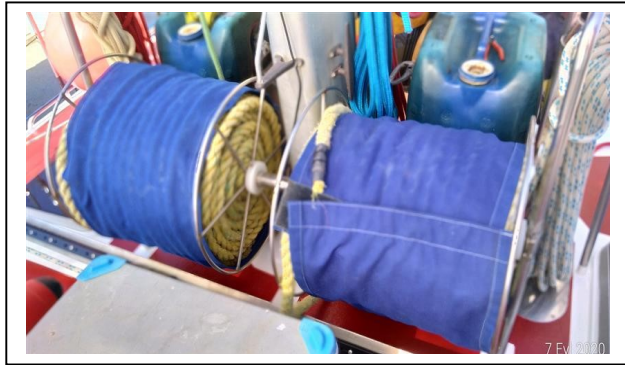
The anchor winch, anchors, the ropes and the chain, has been examined and found in ACCEPTABLE CONDITION.
